Security Assessment of

**Greensville/Emporia
Courthouse
Emporia, Virginia**

**Preliminary Architectural Report
GREENSVILLE COUNTY COURTHOUSE
SECURITY ENHANCEMENT PROJECT**

**OLD OFFICE & BANK BUILDING
Court Square/Main Street
Emporia, Virginia**

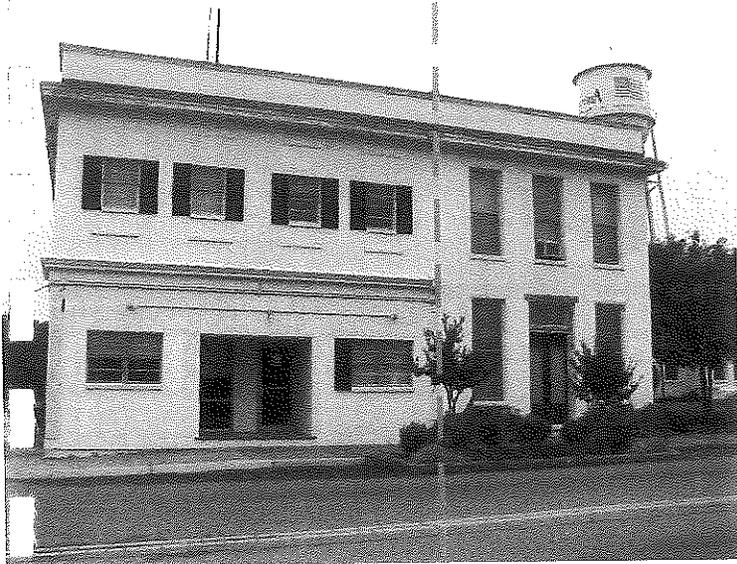
1. West Elevation on South Main Street

The old Bank Building (right portion of Photo 1) appears to be the more original structure of the two, due to evidence viewed in the cornice, windows, doors and parapet wall on the South Main Street side. The interior of the Bank Building first floor is largely original with pressed metal walls and ceilings. These walls and ceilings show significant deterioration.

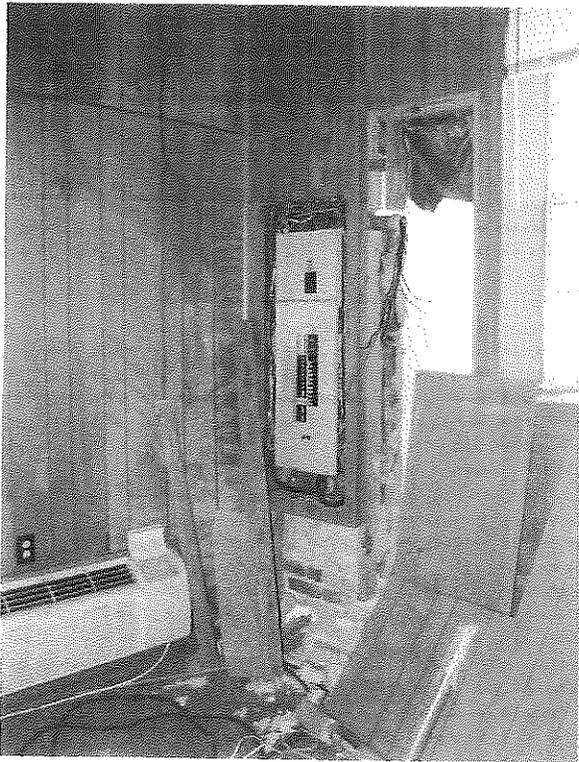
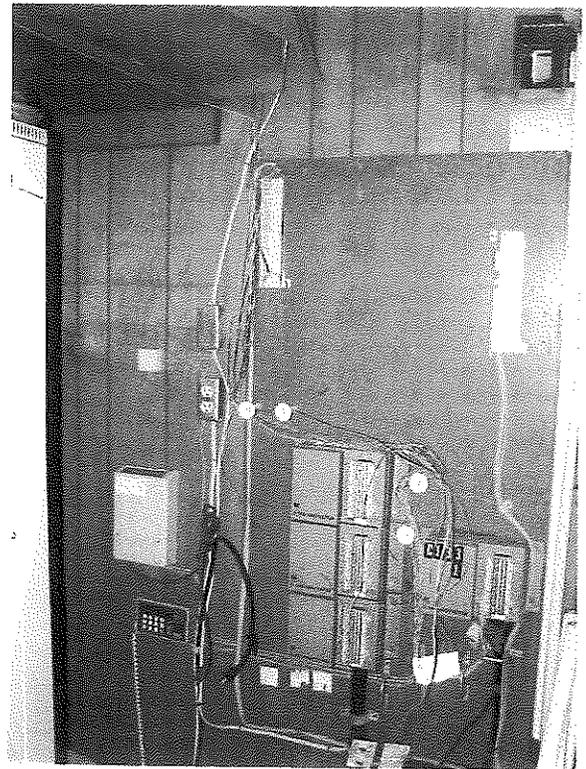
The existing mechanical systems are non-operational and have not been in use for a number of years. They appear to be virtually at the end of their life expectancy and are beyond repair. All new systems would be required as part of any major renovation should the building be brought back on line.

18. First Floor Mechanical Room

19. First Floor Mechanical Room

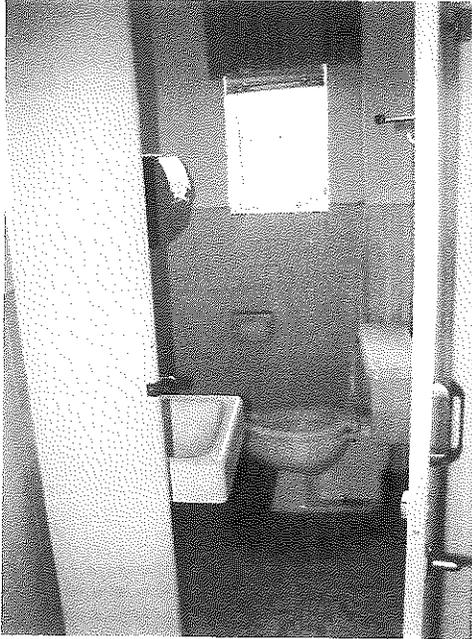
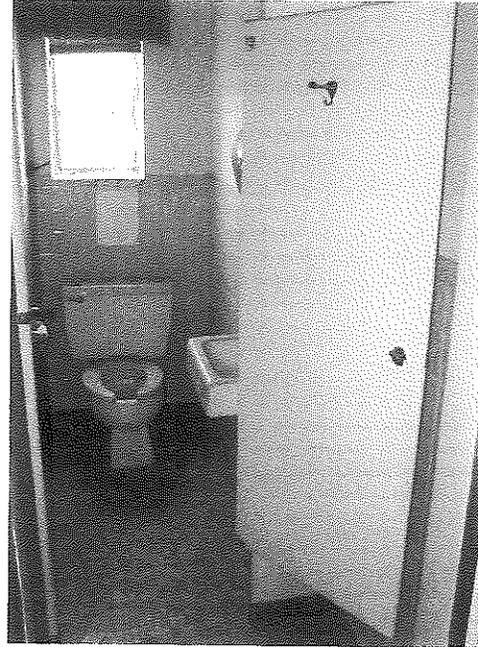
The only toilets visible during inspection are located on the second floor of the old Office Building. They are extremely constricted spaces, and do not meet A.D.A. or current building code standards. There is a possibility of secondary toilets elsewhere that have not been observed. In summary, the toilet system in the combined building is beyond repair or future retrofit, as they now are configured and located.

28. Second Floor Bathroom

29. Second Floor Bathroom
